Decision Document Signed for Wood Island

Marine Corps Air Station (MCAS) Cherry Point and the U.S. Navy, in concurrence with the North Carolina Department of Environmental Quality (NCDEQ), have selected a remedy for old munitions items on and around Wood Island in Bogue Sound, North Carolina.

This fact sheet summarizes the results of previous site investigations and describes the selected remedy, which was chosen because it best balances protecting human safety from explosive risk and meeting established regulatory criteria.

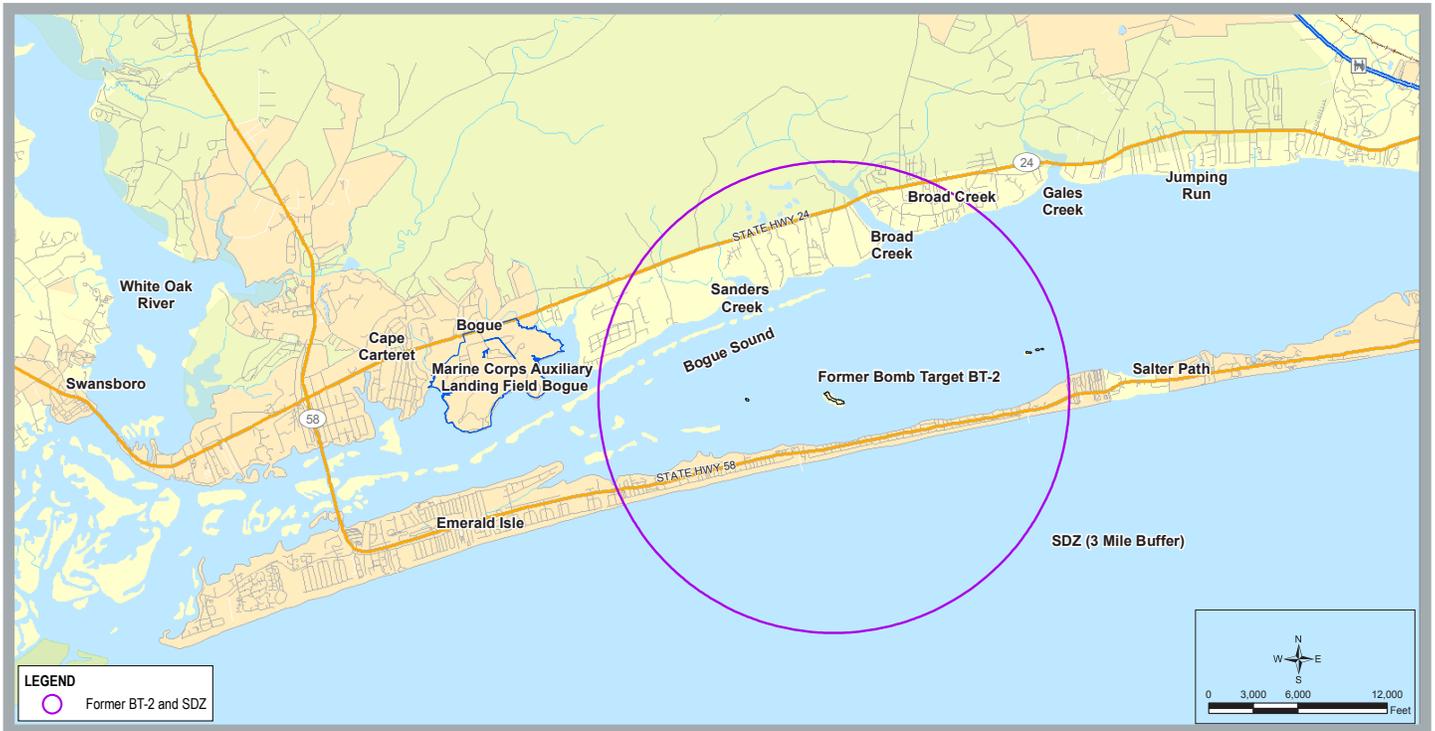
Figure 1 – Investigation area

Former Bomb Target 2 (BT-2) was located near Wood Island in Bogue Sound, approximately ½ mile offshore of 24th Street in the town of Emerald Isle. The target was used for training military pilots in the 1940s and 1950s. Records from that period show that the bomb target coordinates were modified several times during operation of the range, but all target coordinates were located in the immediate vicinity of Wood Island. Surface danger zones (SDZs) associated with those targets extended up to 3 miles in all directions from the former target locations near Wood Island.

In spring 2009, an aerial digital geophysical mapping (DGM) survey was conducted to detect and accurately map metallic items (referred to as geophysical anomalies) within the BT-2 SDZ. The DGM survey identified approximately 10,400 geophysical anomalies, with the highest concentrations clustered within approximately 650 feet of Wood Island.
